# FM Homecheck

## CONFIDENTIAL INSPECTION REPORT

4811 Darrah St. , Philadelphia, PA 19124

1/18/2022 9:00 am to 10:30 am

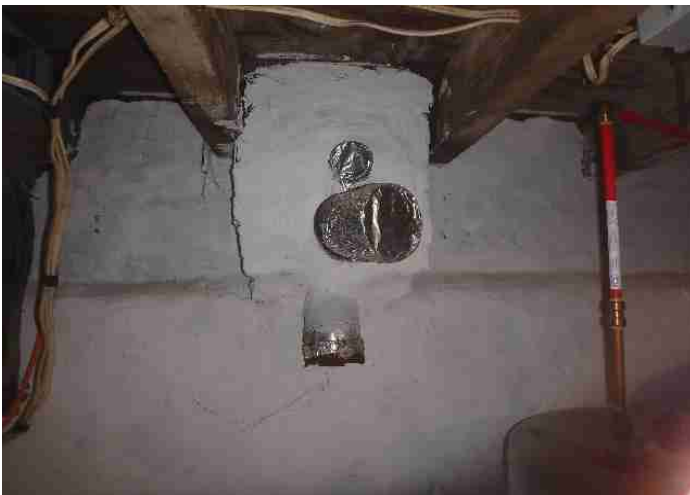
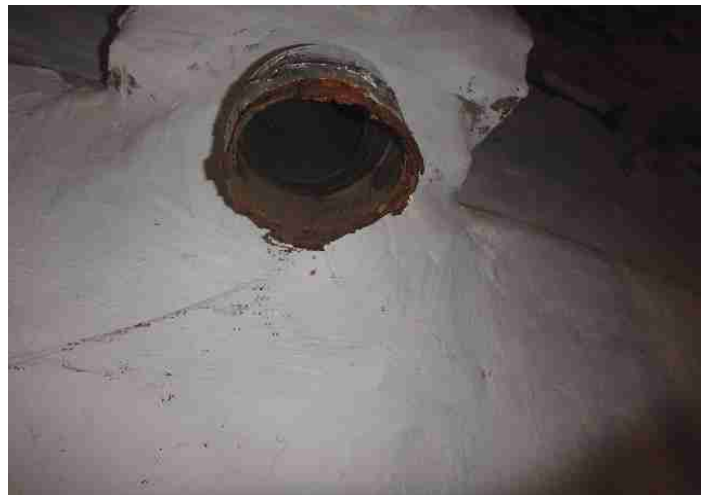
1.2 - Recommend consulting an HVAC contractor to seal off or remove any and all unused chimney access in the basement. There appears to be multiple unused chimney connections; this will waste energy and allow rodents or birds into the home. In addition heat transfer will occur, hot will escape up the chimney and cold air can enter during the winter.

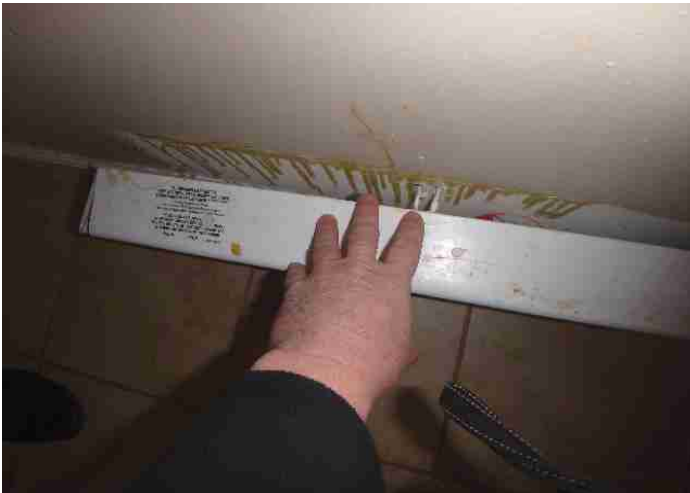
1.7 - Recommend consulting an electrician or equal to secure the baseboard radiator in the first floor bedroom. The radiator is not connected to the wall and is dangling loosely today which will put a strain on the electric wiring.

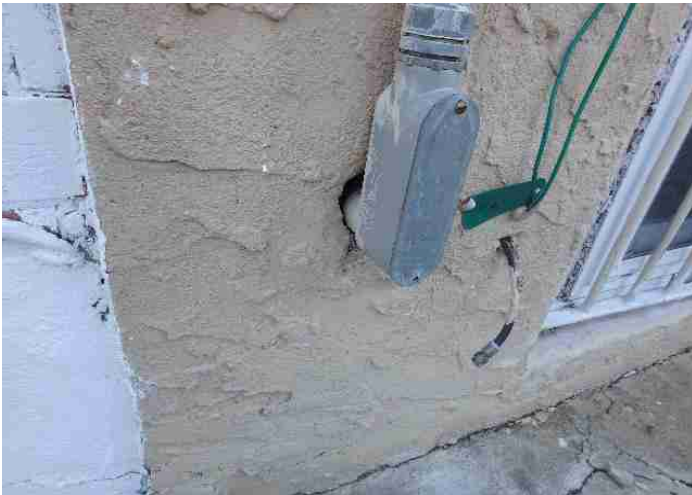
3.3 - Recommend sealing around the service entrance cable where it penetrates through the exterior wall, spaces around the conduit today. Keep water, rodents and insects out. Use exterior grade caulk or equal or consult an electrician.

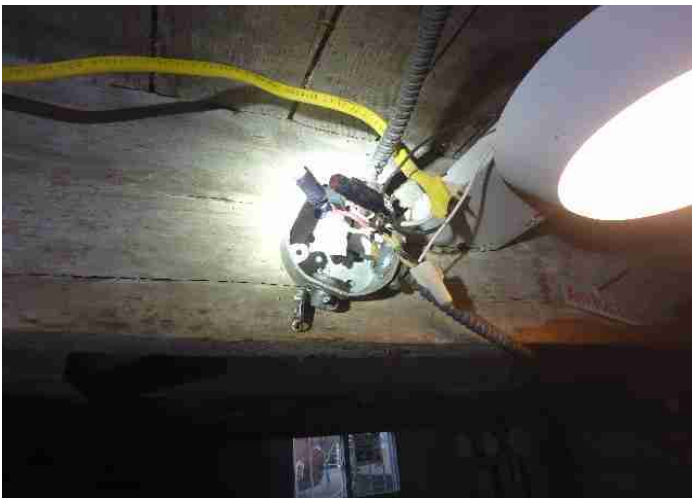
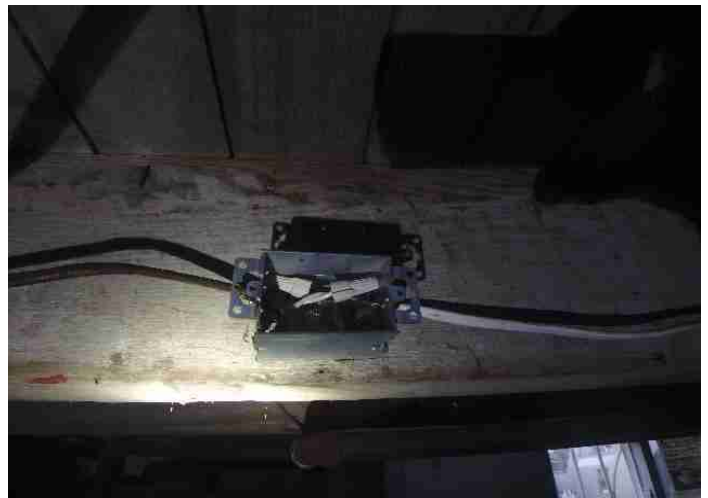
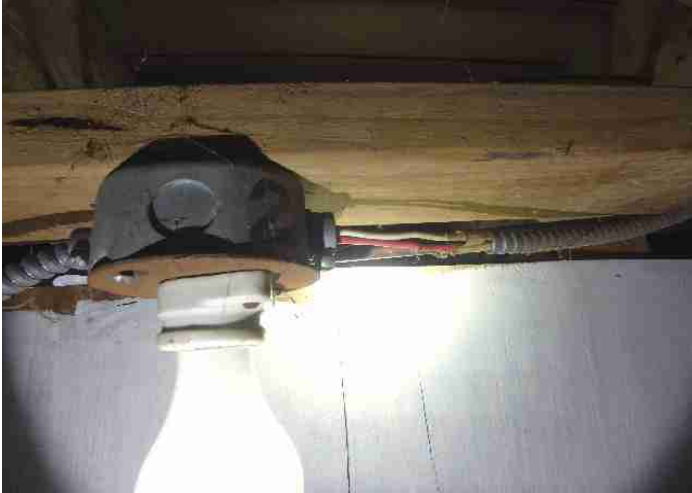
3.11 - Recommend consulting an electrician to add the proper covers to all open electrical junction boxes. I found more than one open junction box in the basement ceiling.

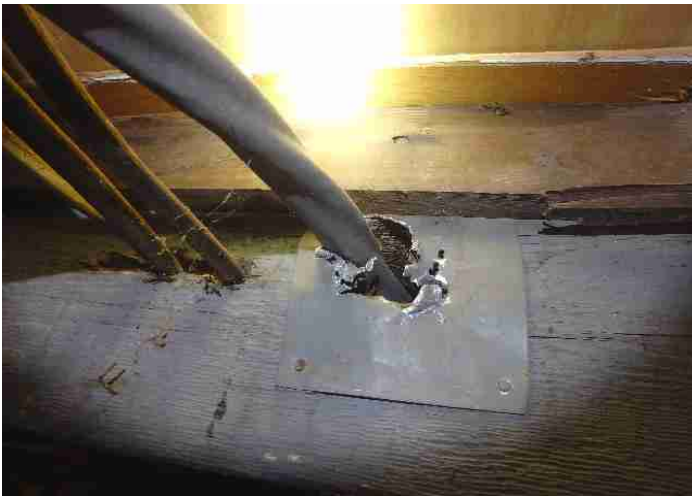
3.12 - Recommend consulting an electrician to secure the loose wires in the basement ceiling at multiple locations. Loose wires can be hung on by people. Secure all wiring to prevent this.

3.13 - Recommend consulting an electrician to add some type of protection to the wires that go through the metal applied to some of the basement floor joist. The wires appear to be in contact with the sharp edges which may cut the protective layer on the wiring.

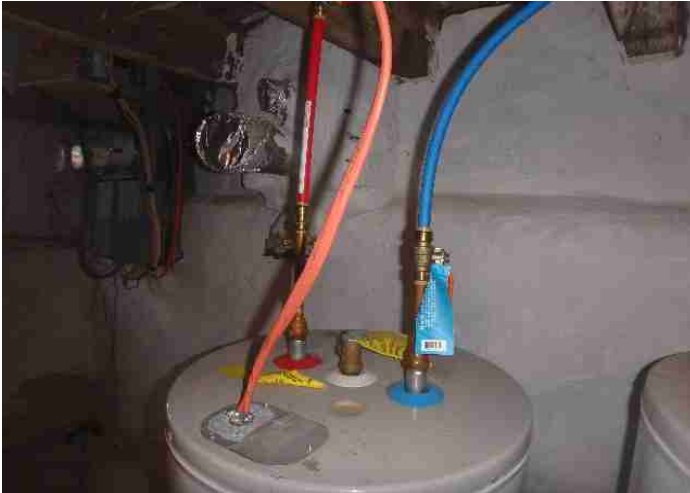
4.8 - The water heater is required to have temperature resistant pipe for the first eighteen inches leaving the unit. This unit has plastic piping connected to the water heater. Recommend having a plumber replace the first eighteen inches with copper or other approved metal pipe.

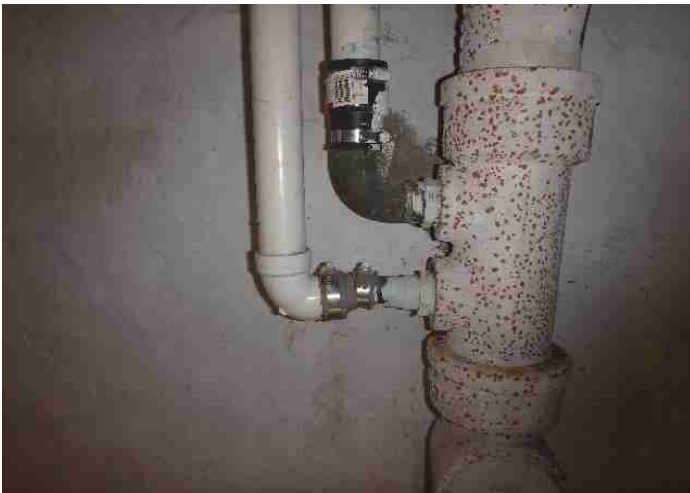
4.14 - Recommend consulting a plumber to replace the undersized pipe visible in the basement. The home has what appears to be two inch PVC draining into a smaller pipe. While this is functional today, this increases the chance for blockage and goes against basic plumbing principals.

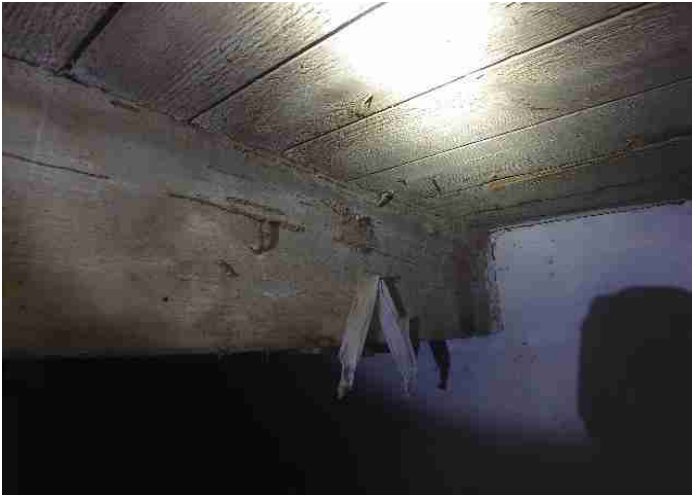
We may not have seen the full extent of the insect damage, the wood pieces in and around the infested area may have been affected also. Consider removing the finished wall covering in and around where the damaged wood was found and determine the beginning and end of the damage.

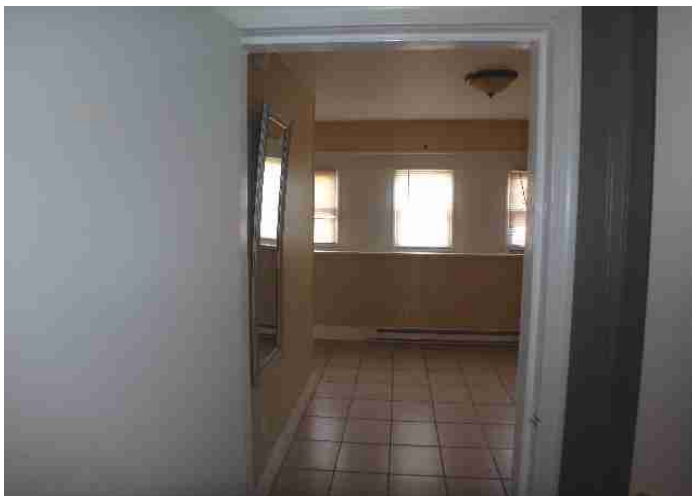
8.4 - Some of the bedroom doors have been reversed. They now open out into the hallway, instead in towards the bedroom. This is a basic fire regulation to keep people from getting trapped in their bedrooms during emergencies. Recommend consulting a carpenter to re install the door properly unless the seller has a permit that allows this variance.  
**AT THE FIRST AND SECOND FLOOR FRONT BEDROOMS.**

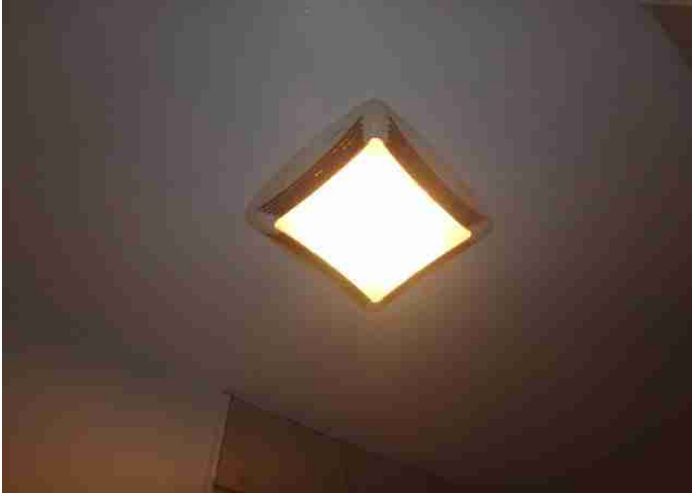
9.4 - The exhaust fan is functional but noisy. THIS FAN IS FILTHY DIRTY, RECOMMEND CONSULTING AN ELECTRICIAN TO REPLACE.

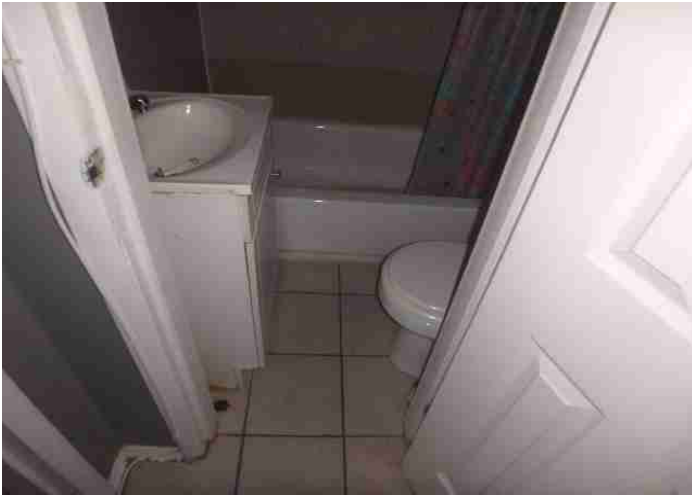
**THE SINK BLOCKS ACCESS INTO THE BATHROOM.**

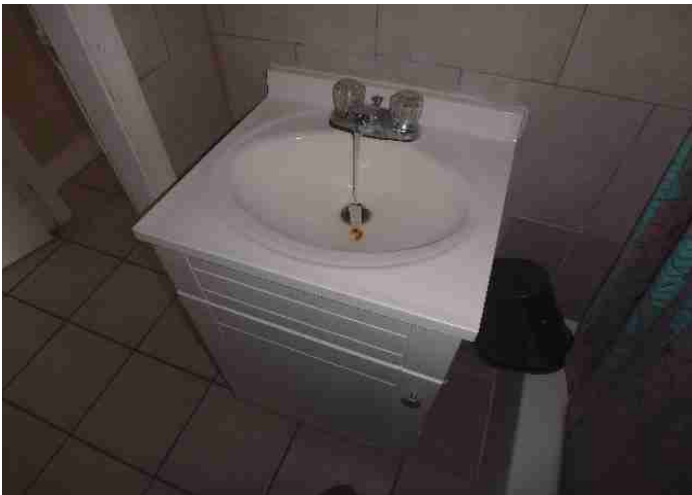
9.8 - Recommend consulting a plumber to secure the bathroom sink faucet which is loose today. This has a high chance of leakage.

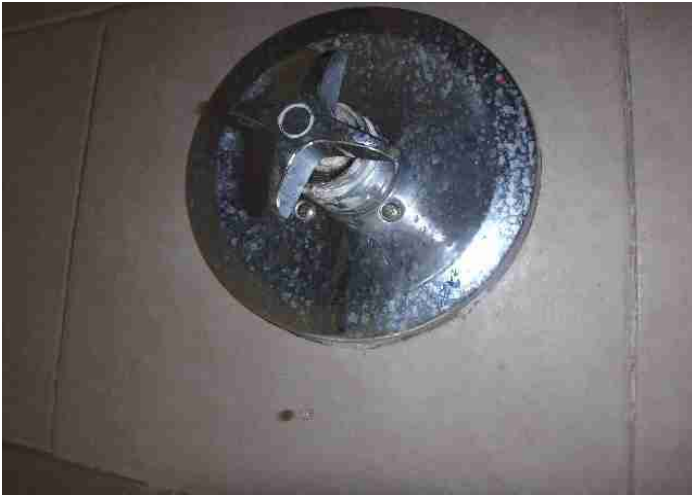
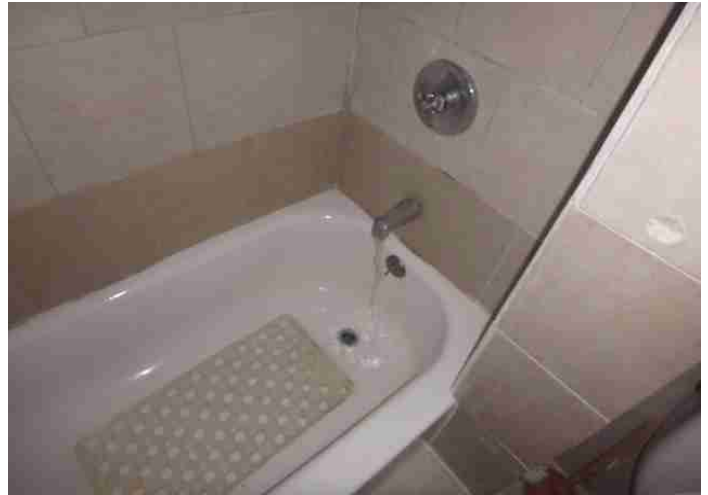
9.4 - Recommend consulting a plumber to repair and or replace the shower faucet in the second floor units bathroom. Presently the faucet leaks from the handle when operated, this water may leak into the wall cavity behind the faucet.

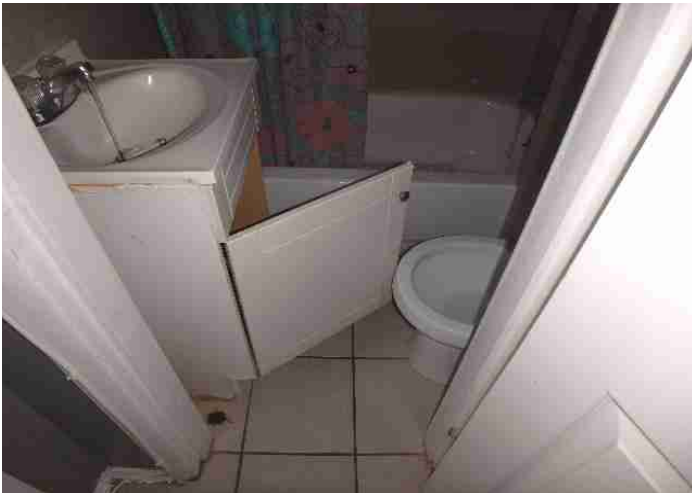
9.16 - The sink base cabinet has typical, cosmetic damage, but the door cannot be opened completely, it bumps into the toilet. This is an amateur mistake.

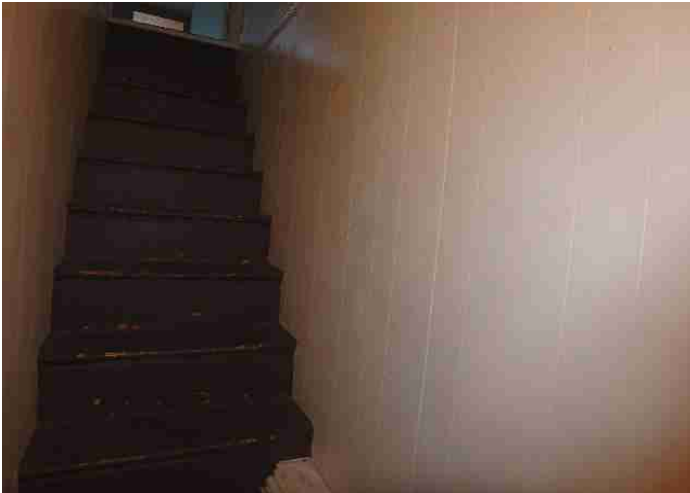
12.2 - Recommend consulting a carpenter or equal to install a handrail for the steps to the second floor. None today.

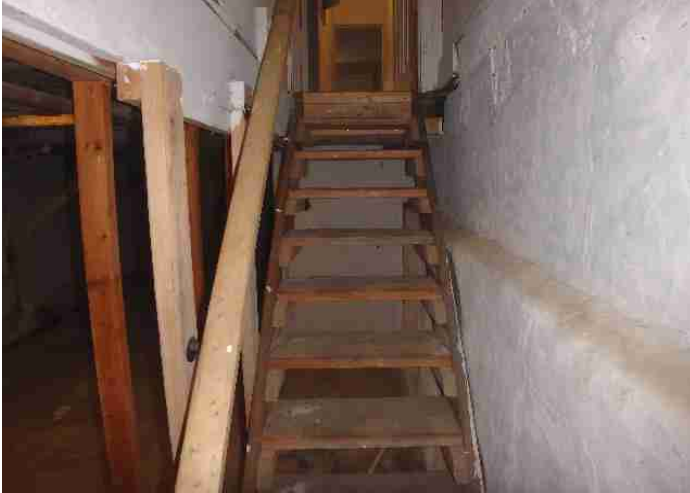
12.2 - Recommend consulting a carpenter or equal to install some type of filler to prevent someone from tripping or falling through the stair risers at the basement staircase. Currently these steps have large spaces between the treads. No space should be greater than 5 inches to prevent injury.

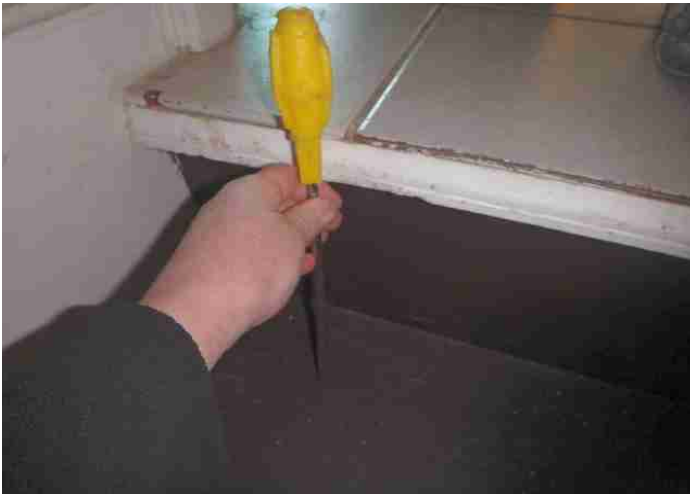
12.5 - The top most step at the second floor is significantly more than the others. This is a trip hazard and represents amateur work. Recommend consulting a carpenter to see if this can be repaired or you will need to replace this stairway.

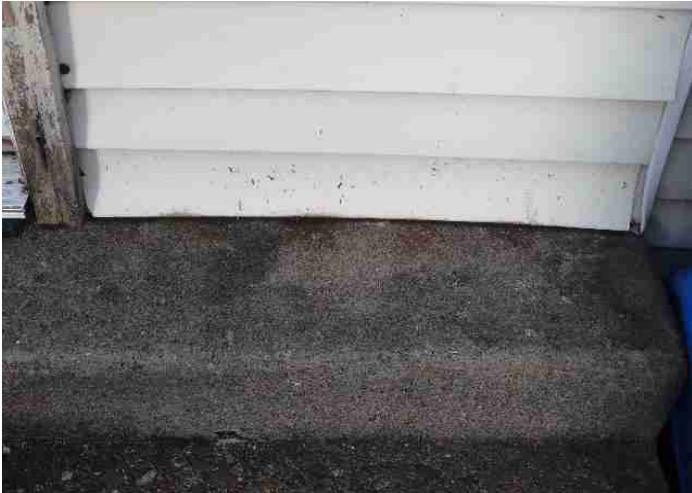
13.2 - This homes walls are covered with vinyl siding at some locations. The siding is held in place with a horizontal piece of J-channel that is in direct contact with the concrete walkway. This will fill with rain water or melting snow. There should be a different piece of siding used here called a starter strip and the starter strip should be above the horizontal surface by at least six inches. Recommend consulting a siding contractor to remove the bottom section of siding so it is not in direct contact with the ground. The exposed section of wall will need to be examined once the siding has been removed, to verify if there is any moisture damage behind the siding. The lowest part of the wall will need to be covered with durable/approved siding material that can withstand ground and soil contact. Then the siding can be re installed starting at least six inches above the horizontal surface.

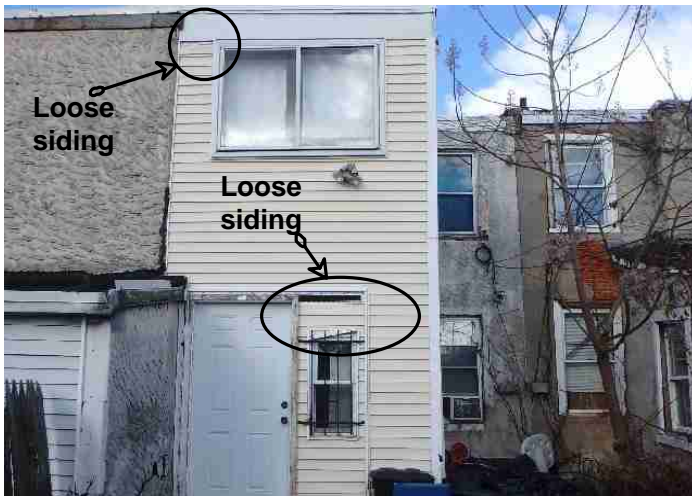
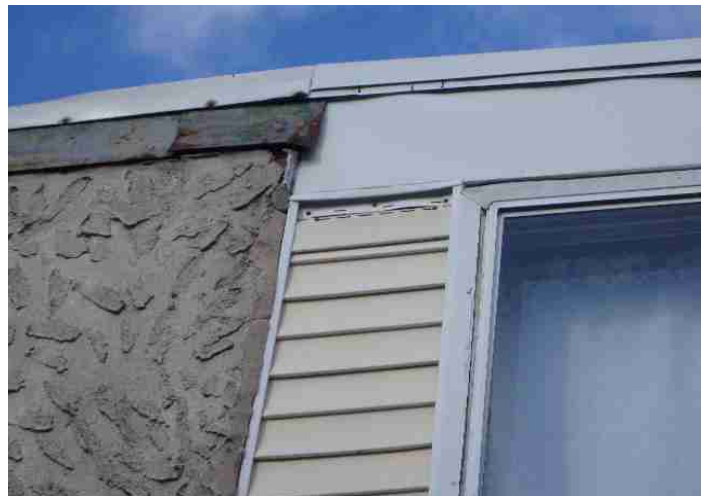
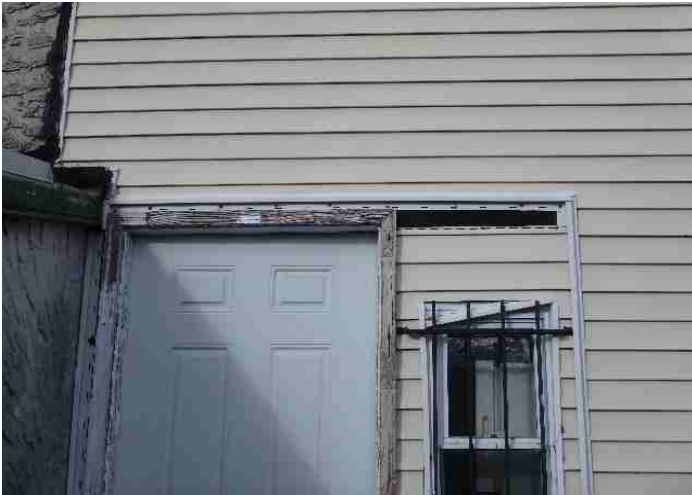
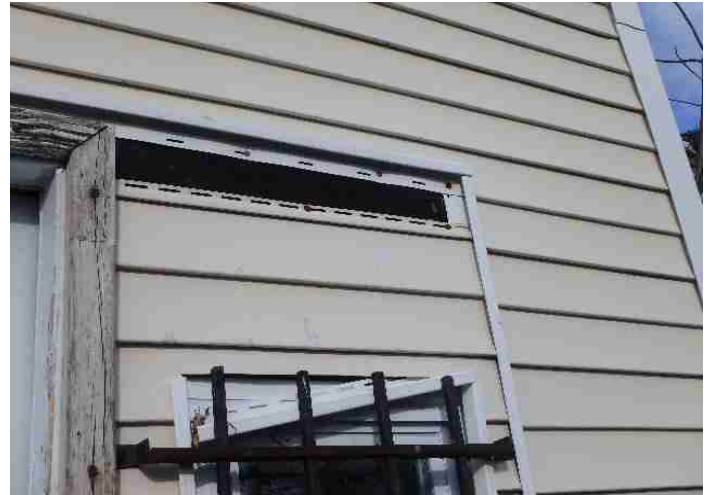
13.3 - Recommend consulting a siding contractor to repair the siding at the following locations:

1. The rear of the home has loose and missing siding at many locations. This siding may get torn off during extreme weather conditions and has a high chance of leakage into the home.

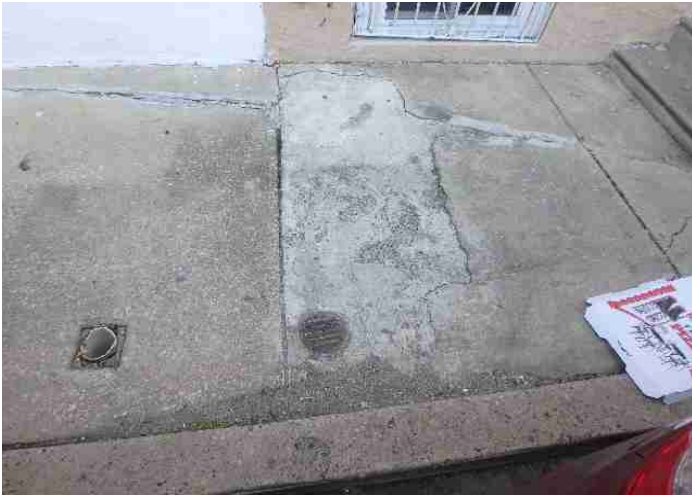
13.3 - Recommend consulting a carpenter or equal to caulk and seal the cracks/separations at this homes concrete walkways. Many small cracks observed.

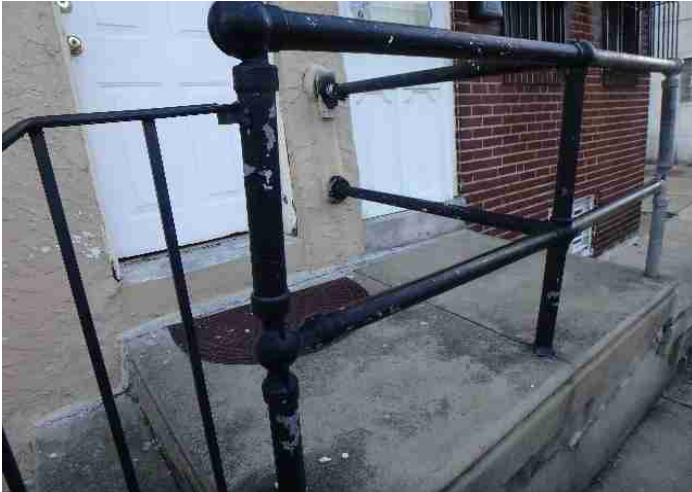
13.6 - Recommend consulting a carpenter or equal to fill in the spaces at the front and rear stairway railings. Currently there are spaces large enough for a child to fit through each side of the railings. Ideally there would be no space greater than 5 inches at the stairway railings.

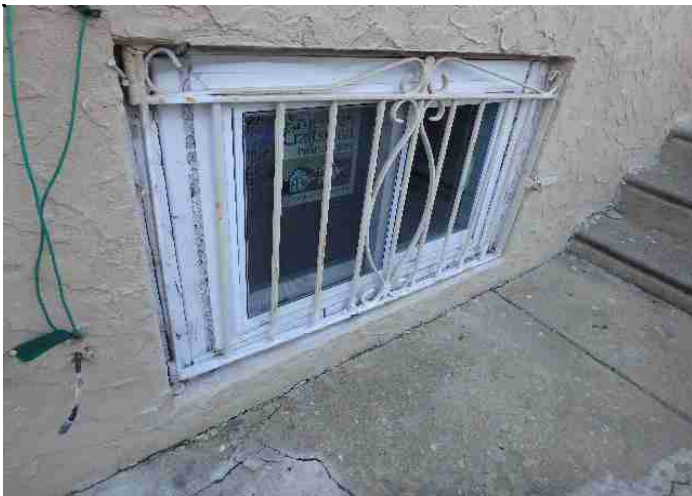
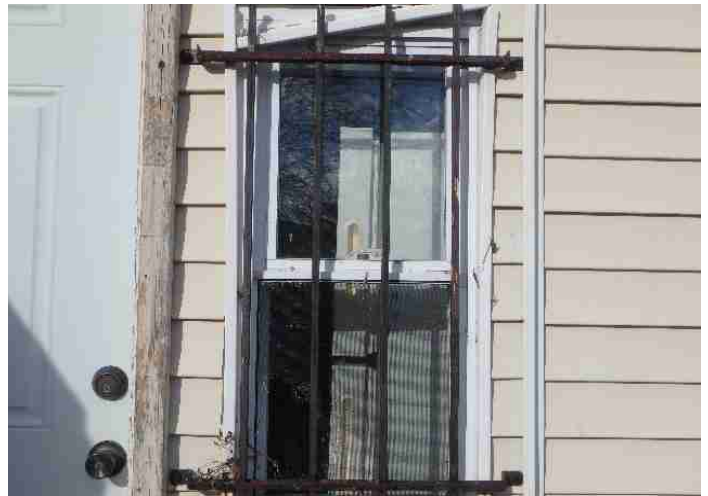
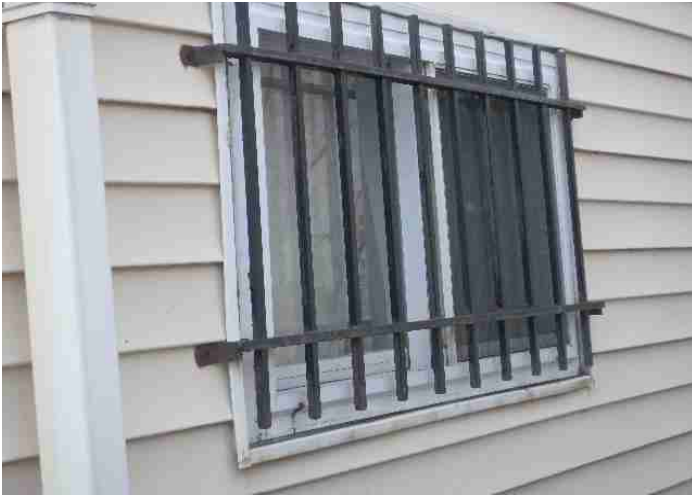
13.8 - Recommend removing any and all bars that are in front of this buildings windows. Windows are a secondary fire exit and should not be blocked or obstructed in any manner. If you feel the need for security bars they should be the type that can be removed from the inside without using any special tools.

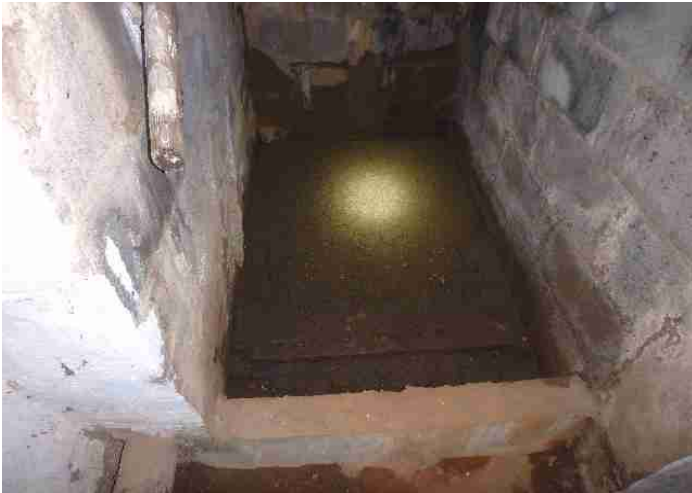
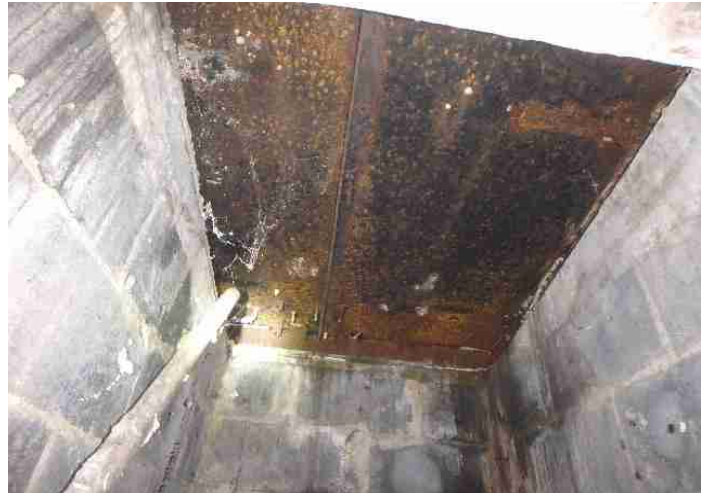
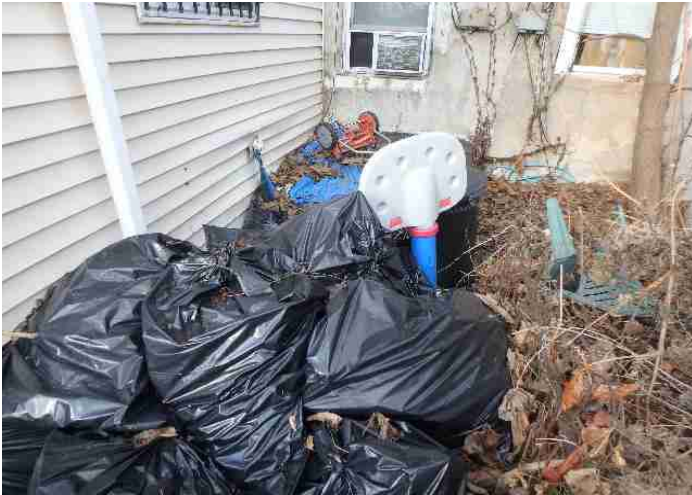
13.9 - Recommend replacing the damaged basement hatch door. This door is not well sealed and allows water to leak into the basement. Recommend consulting a door contractor to install a Bilco brand style steel hatch door at this location. **THE AREA ON THE OUTSIDE IS COMPLETELY BLOCKED OR COVERED WITH TRASH BAGS FULL OF DEBRIS.**

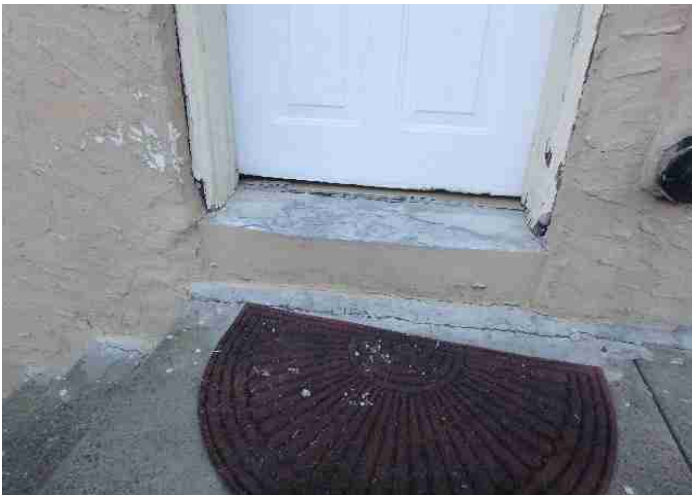
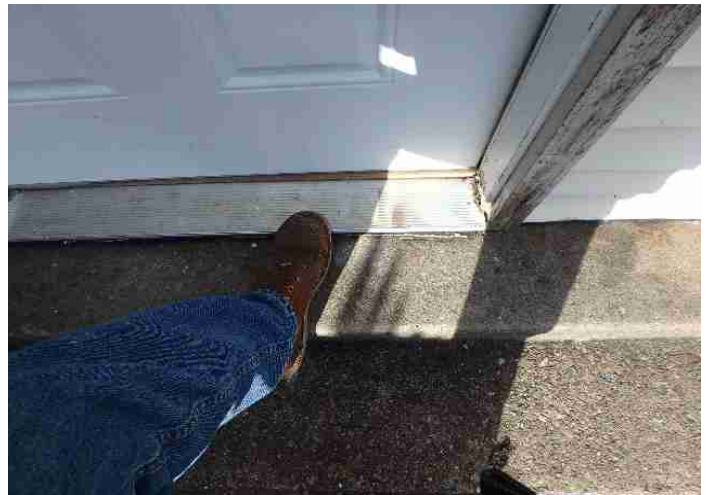
13.10 - Recommend consulting a door contractor or equal to seal the front and back door thresholds better. Today there are spaces/gaps that will allow water to migrate into the home.  
The threshold at the rear is rotted and loose.

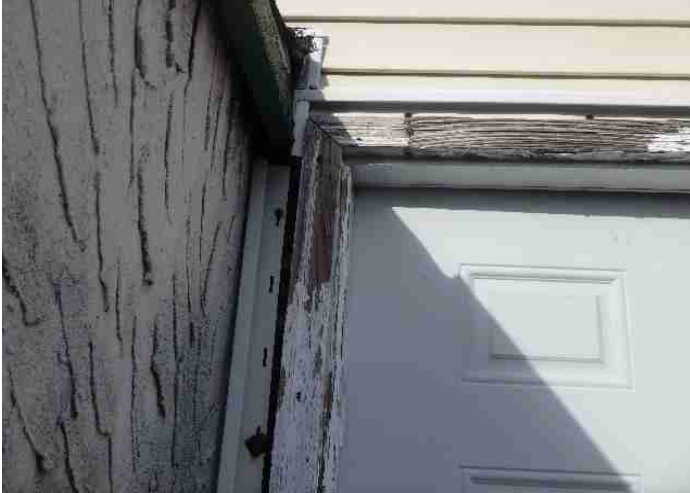
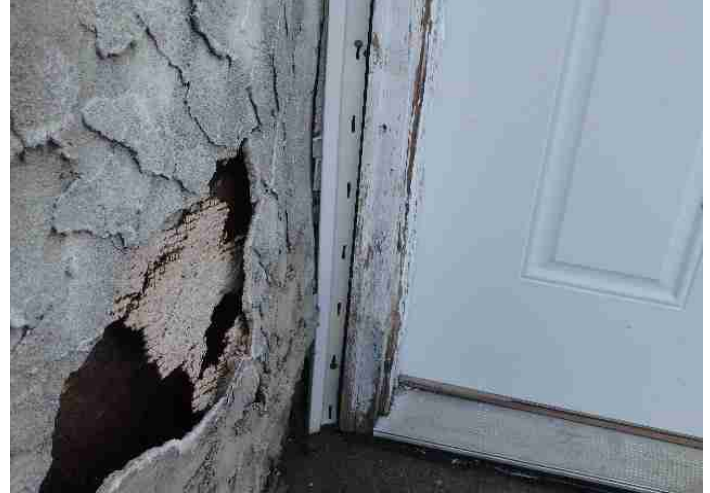
13.11 - Recommend consulting a door contractor or equal to cap all exposed wood around the rear exterior door of this home. There are spaces between the rear door jamb and the siding that will allow water to migrate between the building materials. There are exposed pieces of wood that should be capped or painted to protect them from the weather.

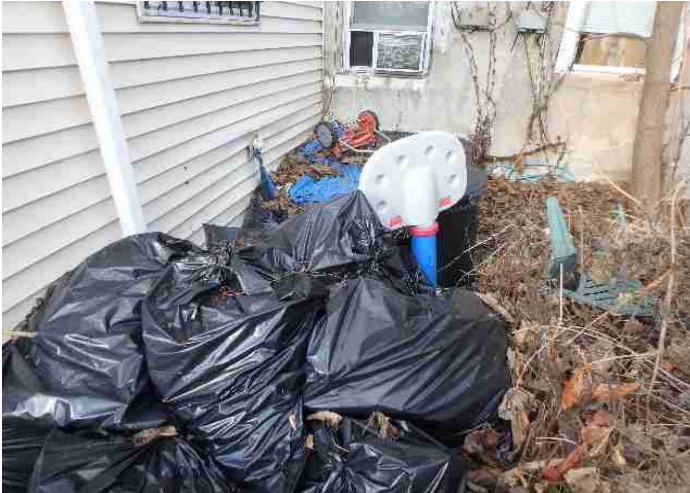
13.13 - I could not find a drain at the rear of the home. I suspect the trash and debris is blocking access to the drain. This drain must be kept clean for proper drainage. I suspect that this drain may be clogged due to the downspout drain is full of water. I recommend further inspection of this drain by a plumber since I was not able to inspect it today.

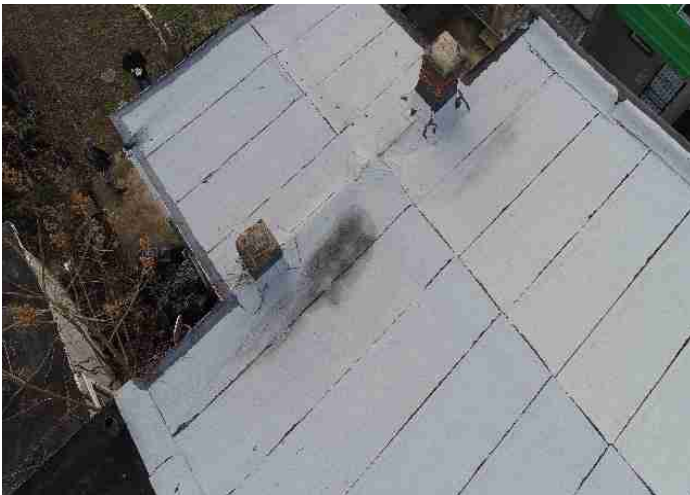
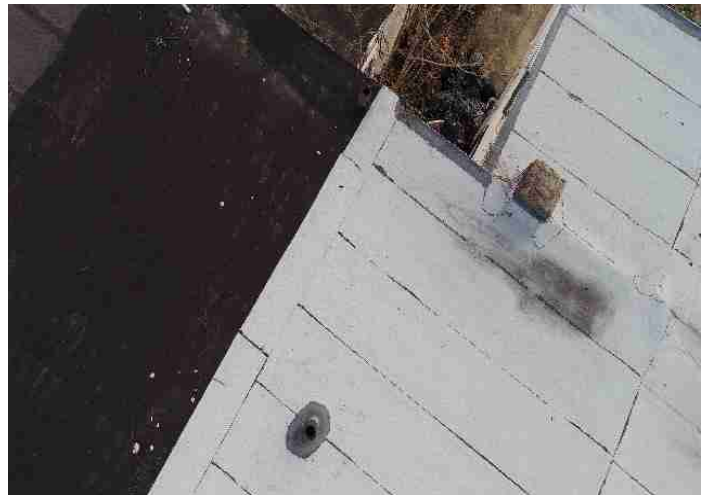
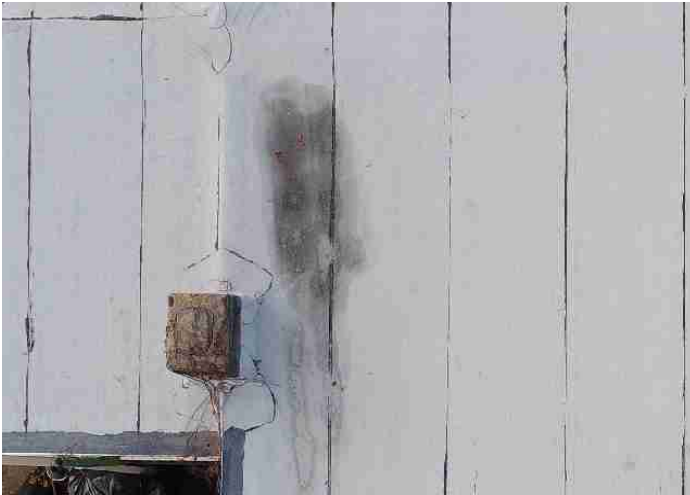
14.3 - Recommend consulting a roofer to repair or replace the depressed section of roof that is not draining today. This depressed sections of roof will freeze below 32 degrees Fahrenheit. Freezing water will damage the membrane, all water should drain from this type of roof via gravity. THIS IS NOT LEAKING TODAY.

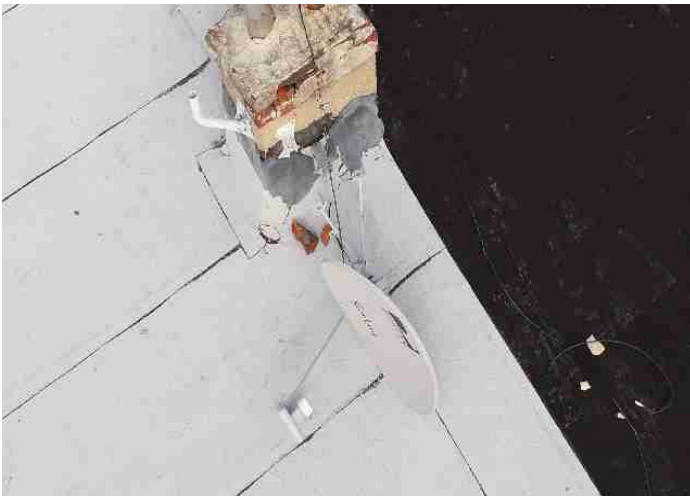
14.4 - Recommend consulting a roofer to remove the debris, leftover dish antennae. This debris will interfere with the drainage of the roof.

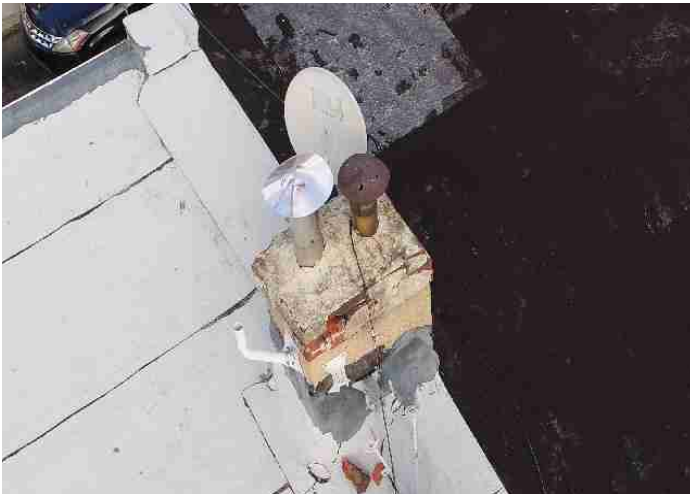
18.1 - Recommend consulting a chimney contractor to seal up or remove the unused chimneys at the roof. Consult chimney contractor for prices and methods to remove the masonry chimney or seal up these openings in the building effectively. The chimney is no longer necessary and should be sealed up to prevent heated air from escaping up the chimney. In addition, keep rain water out and nesting birds or other wildlife from nesting in this unused space.
