# FM Homecheck

## CONFIDENTIAL INSPECTION REPORT

4811 Darrah St. , Philadelphia, PA 19124

1/18/2022 9:00 am to 10:30 am

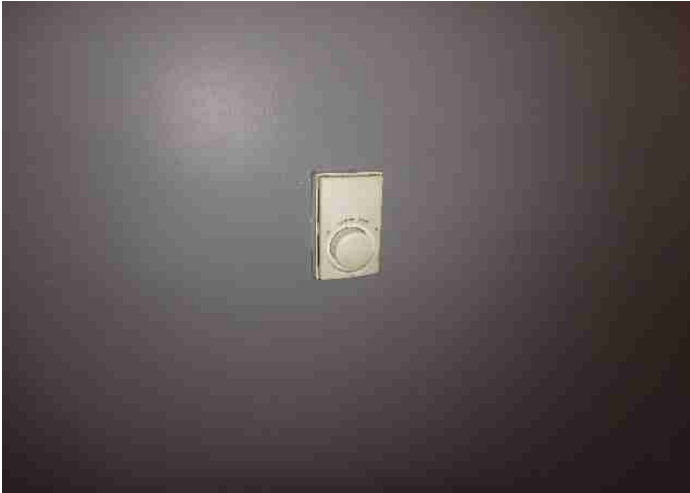
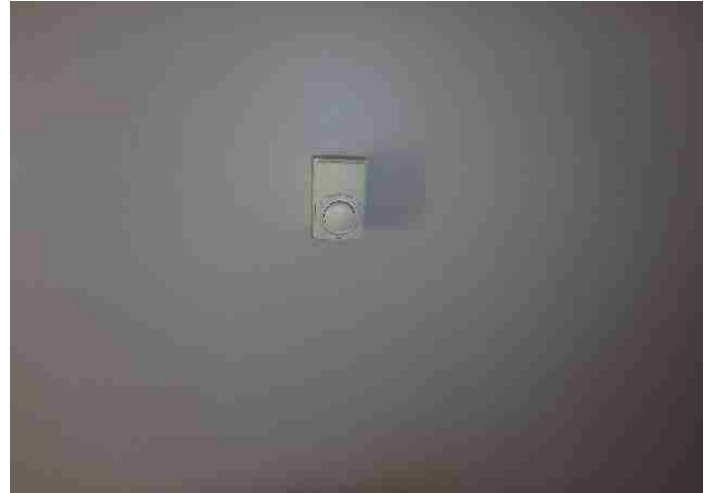
1.8 - The thermostats I operated functioned unless specifically noted below.

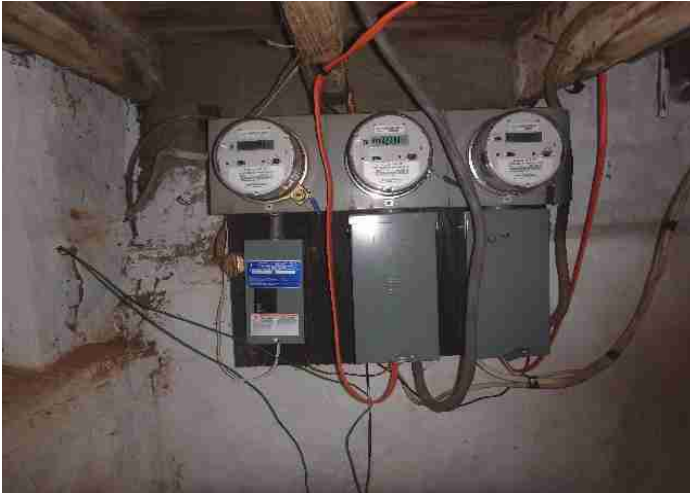
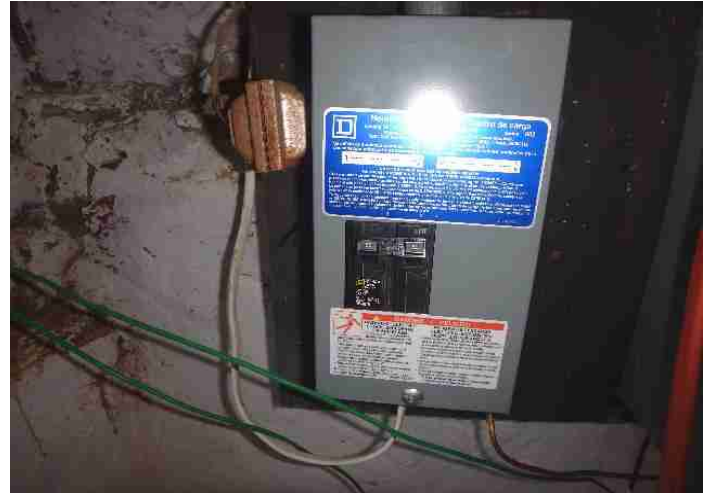
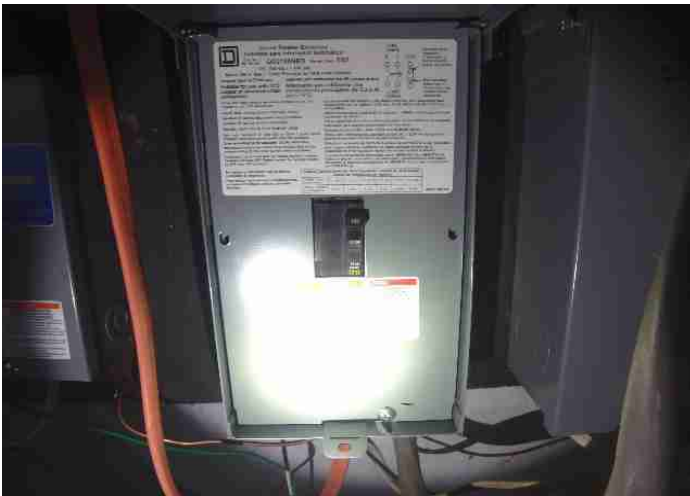
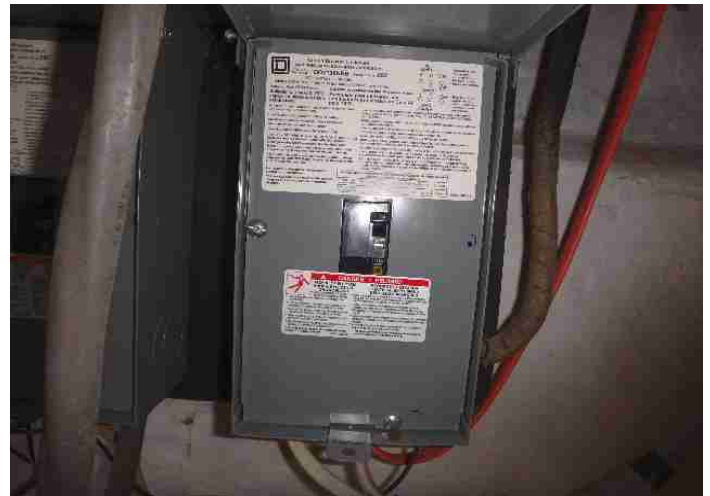
3.4 - This property is served with multiple electric panels. The building has three (3) electric meters and three (3) electric panels. There are two 100 and one 60 amp 240 volt panels. All comments will apply to all panels unless specifically noted.

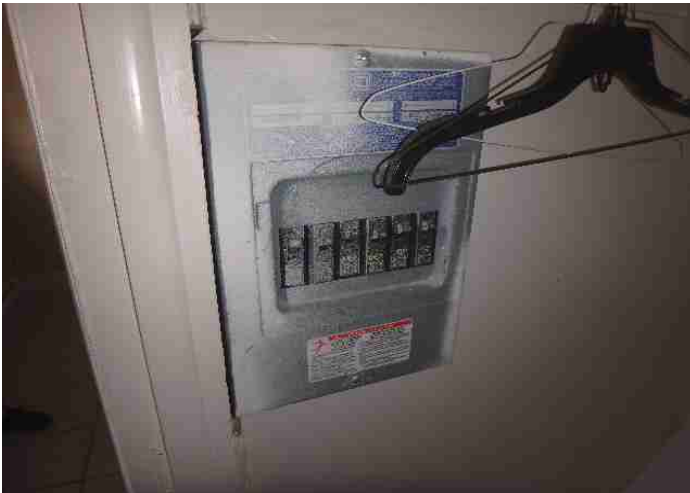
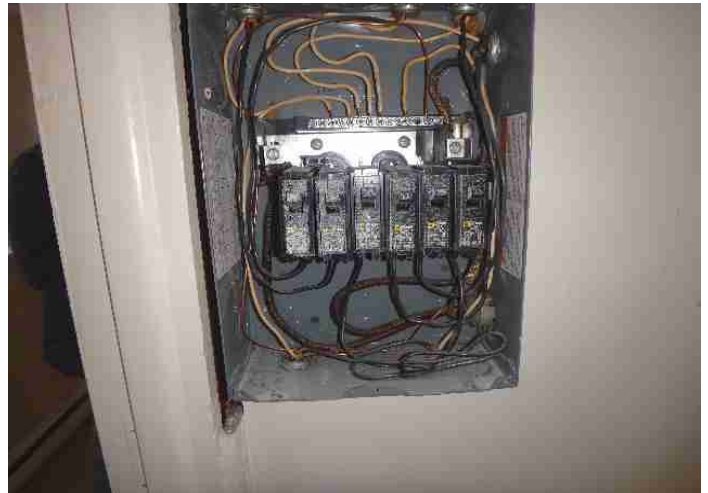
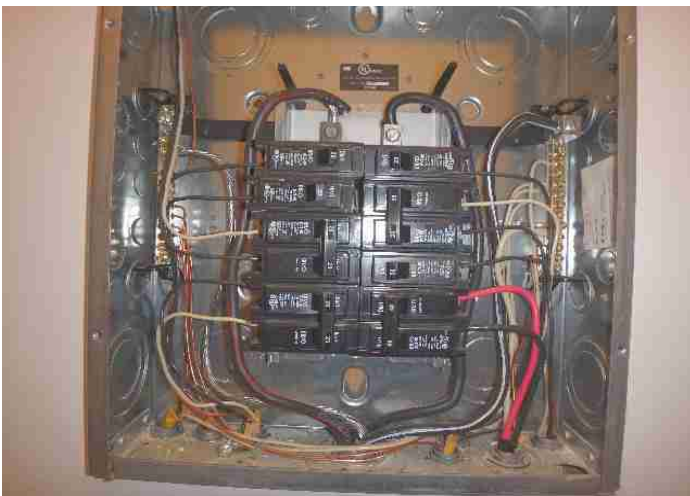
3.17 - The electric sub panels are located in each of the units.

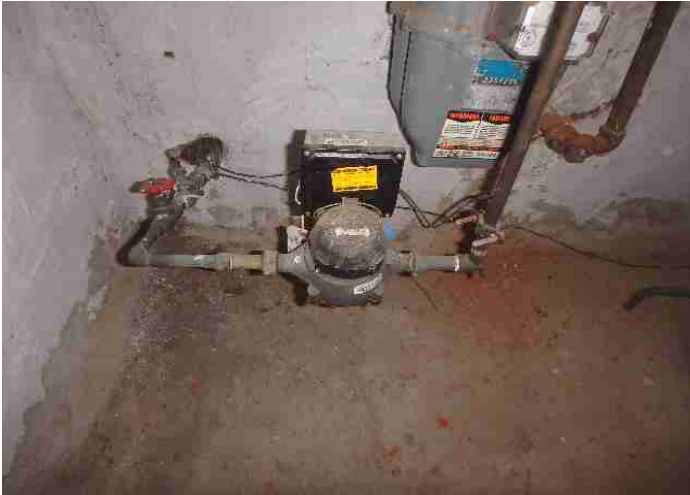
4.1 - The main water shut-off valve is located in the basement front.

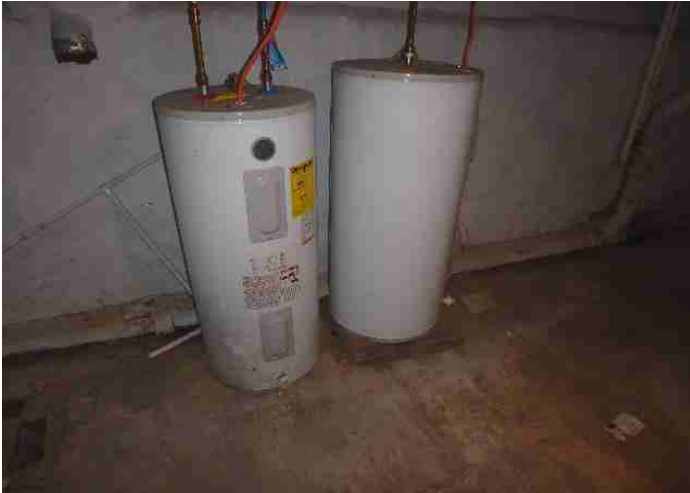
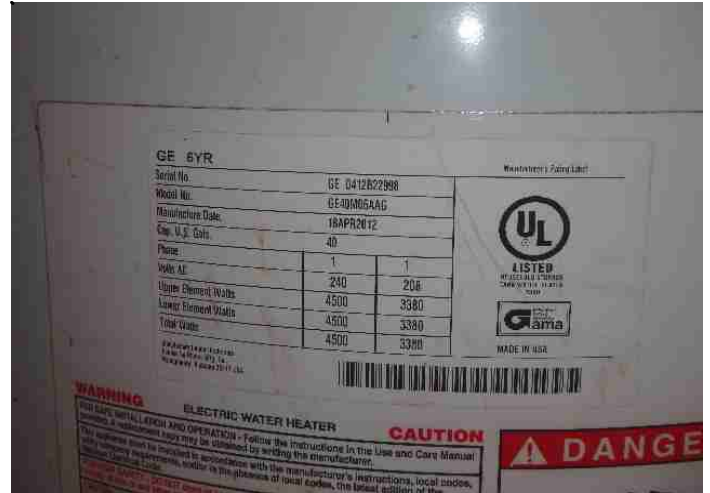
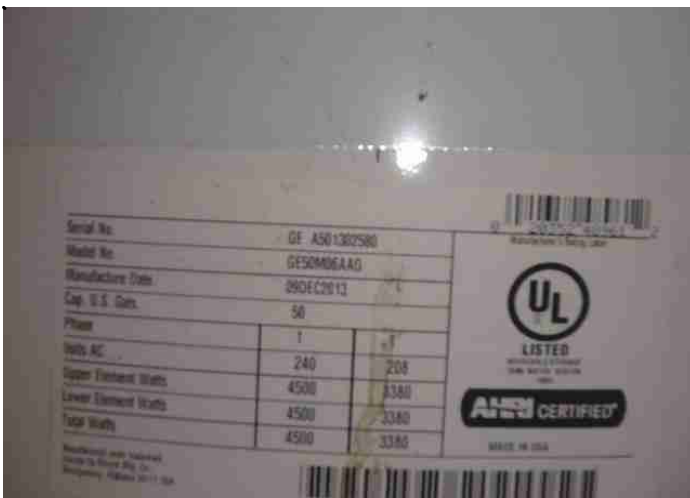
4.6 - This property is served by two (2) electric water heaters located in the basement. Both units are approximately 8 - 10 years old.  
**ALL COMMENTS WILL APPLY TO ALL UNITS UNLESS SPECIFICALLY NOTED.**

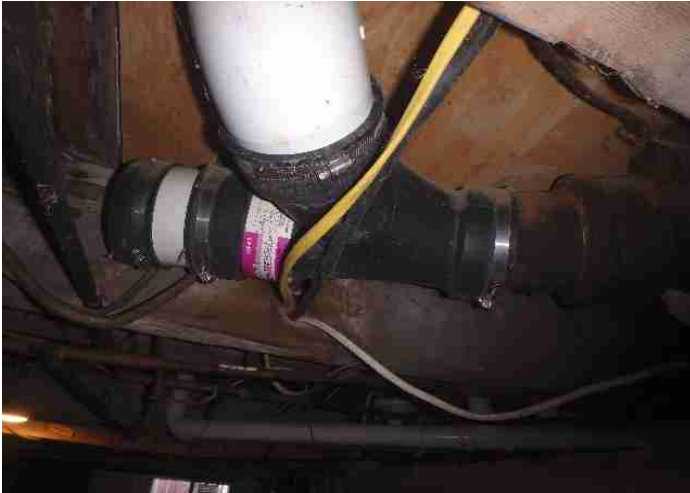
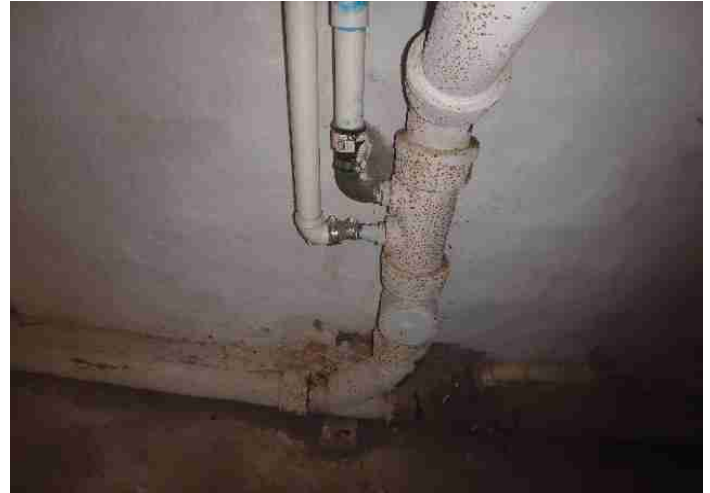
4.12 - The visible portions of the drainpipes consist of more than one material. This home has visible cast iron and plastic pipes used for drain, waste and vent piping. Visible in the basement.

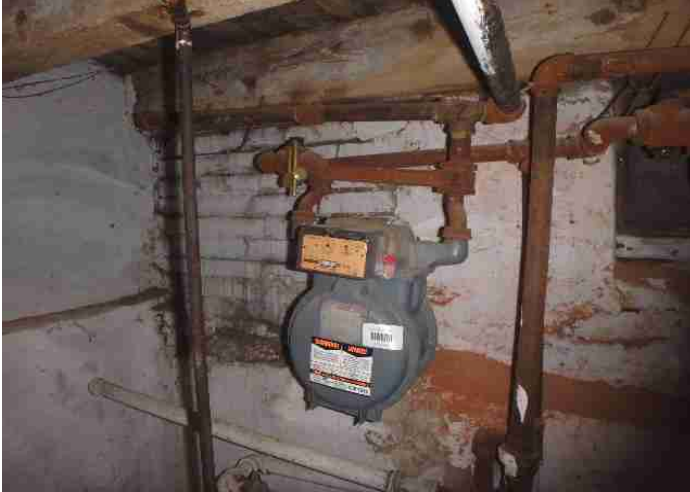
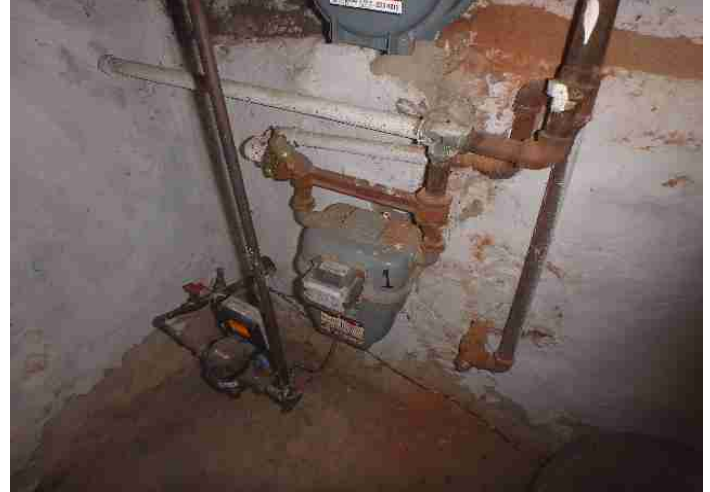
4.15 - The gas service is turned off today, indicating there is no gas at this property.

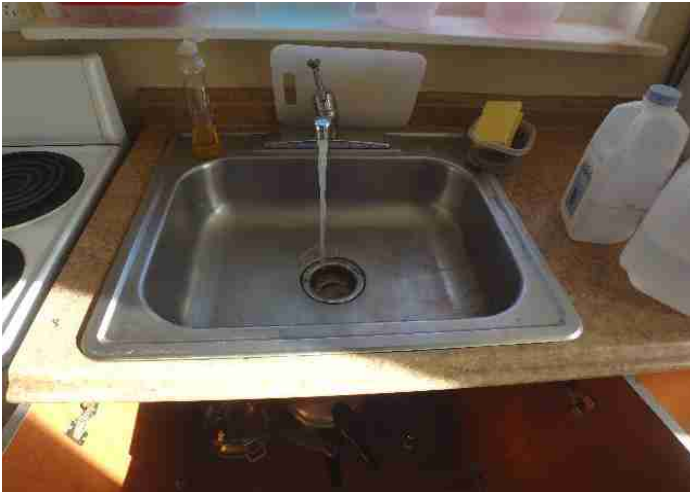
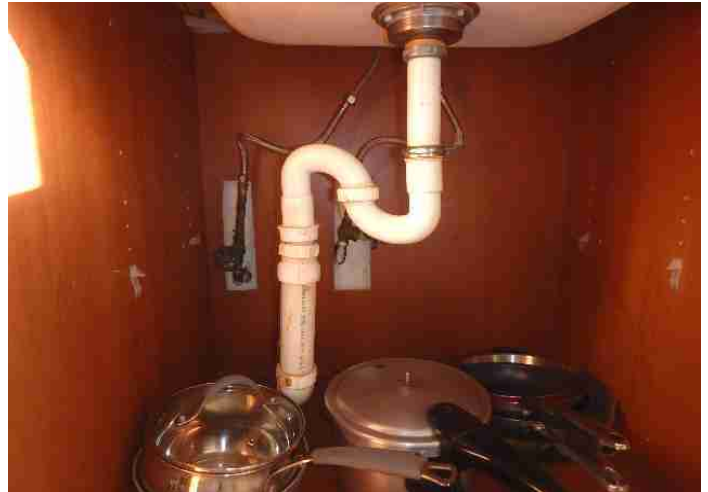
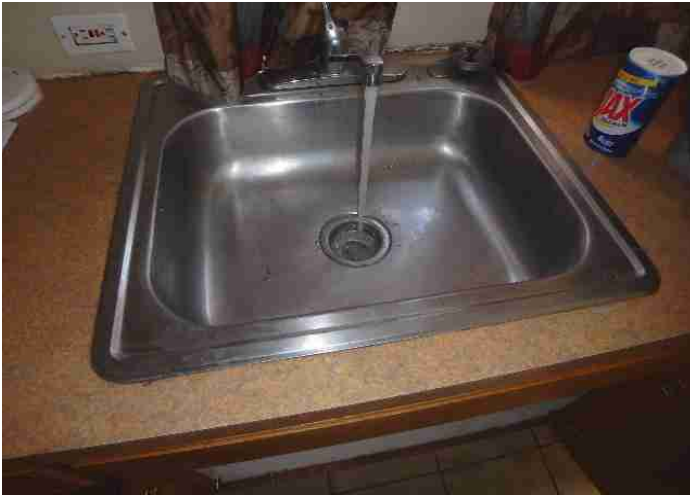
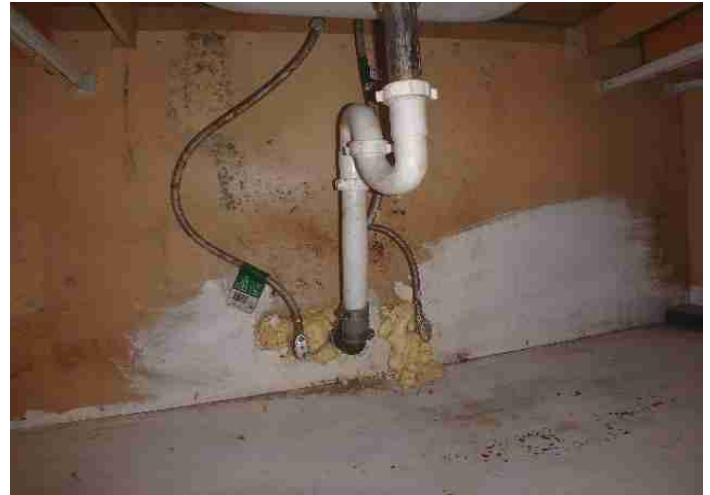
6.7 - The trap and drain are functional. We operated the faucet and allowed the water to run for at least one minute at full strength. The drain kept up with the faucet. The trap appears to be in acceptable condition, no visible leaks today.

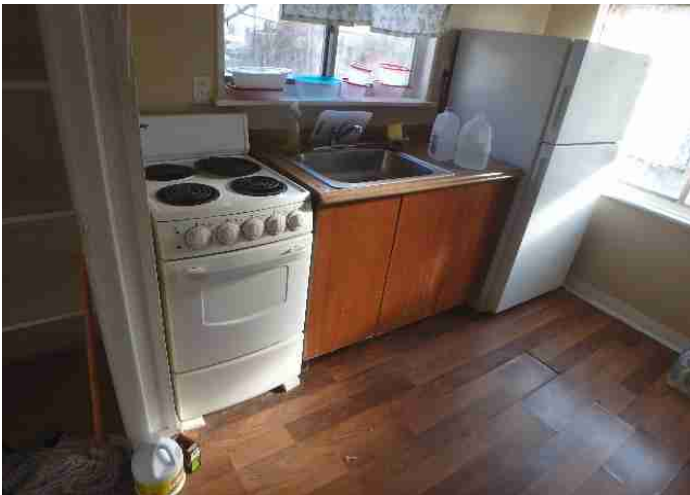
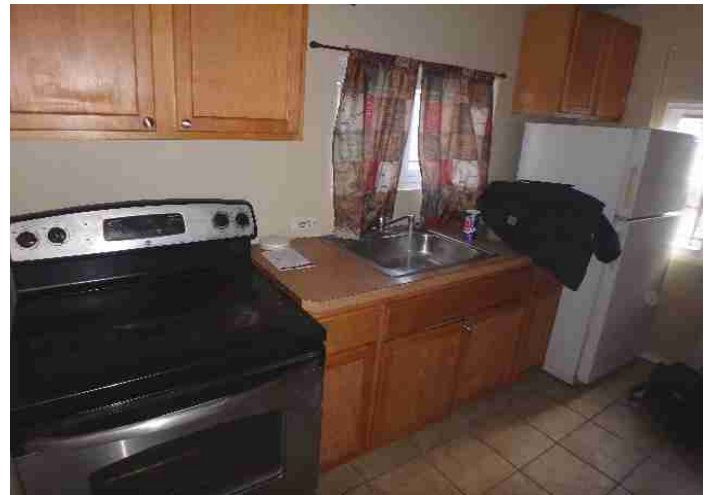
6.9 - The cabinets are functional, and do not have any significant damage unless specifically noted below. We try to open all cabinets and operate all drawers. We tug on the upper and lower cabinets to verify their attachment.

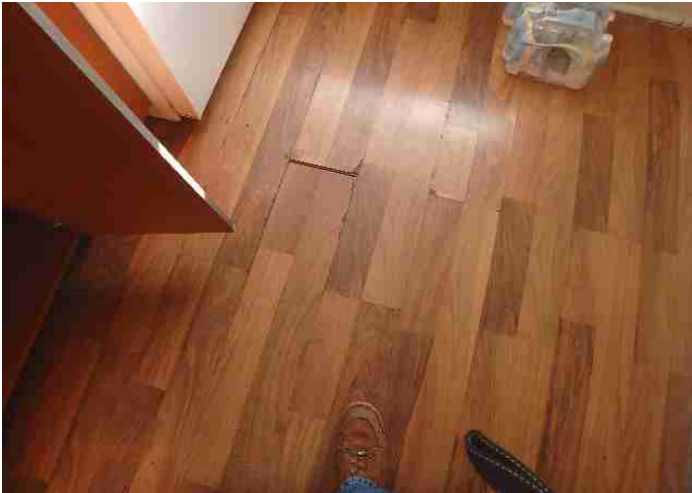
6.13 - This homes kitchen floor is worn at the second floor unit and you may want to replace.

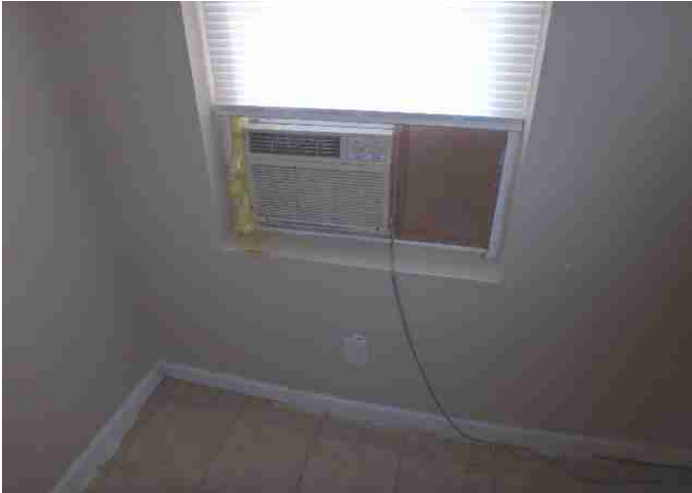
8.5 - I was not able to operate some of the windows in the bedrooms due the air conditioner in the way.

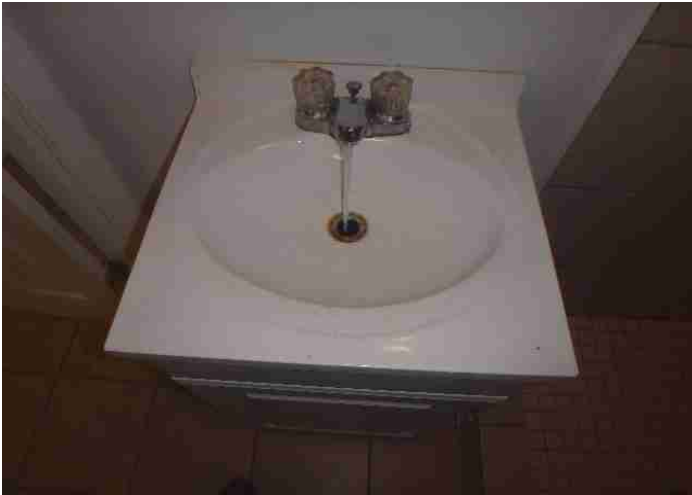
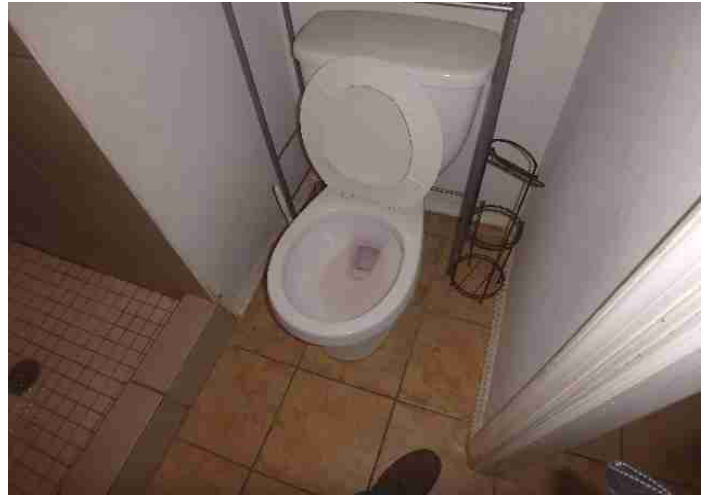
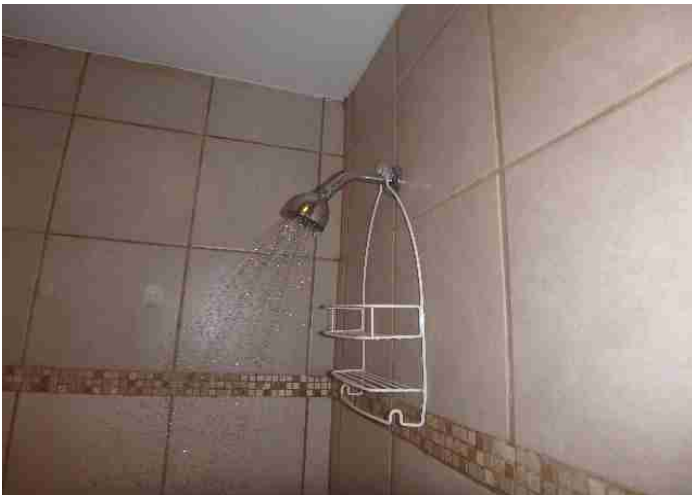
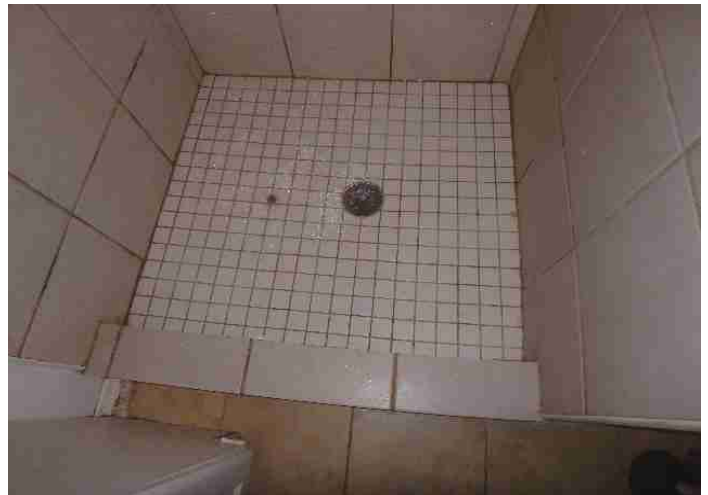
9.2 - We have evaluated the first floor bedroom bathroom, and found it to be in acceptable condition unless specifically noted below.

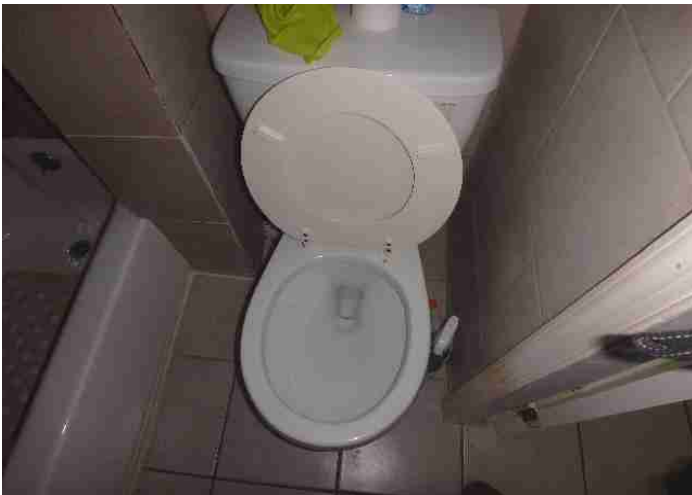
9.10 - The toilet is secure. I was able to operate the toilet in this bathroom. The unit flushed and appears to function in an acceptable manner.

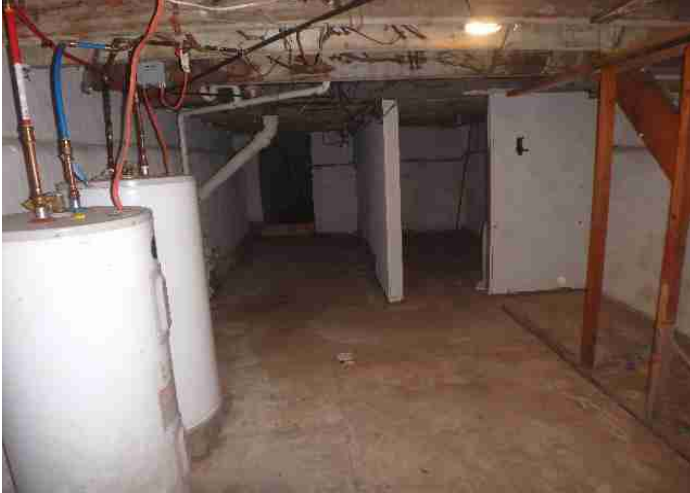
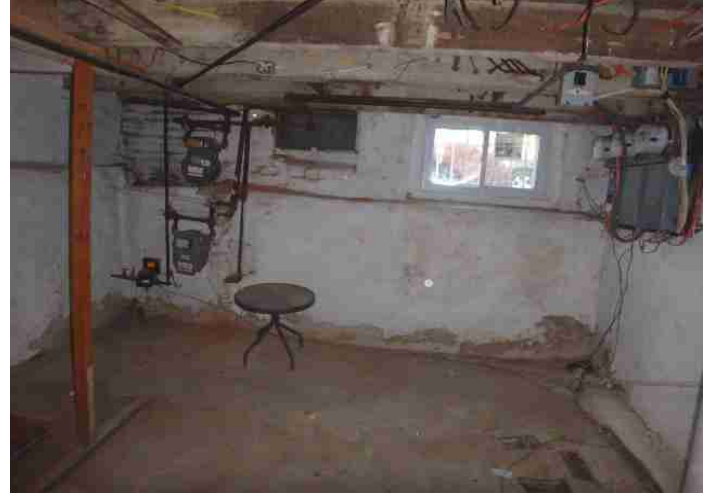
10.10 - This home has an unfinished section of basement. The foundation walls are exposed and so are the floor joist above. This unfinished space is not considered living space. This room does not require heat or secondary egress.

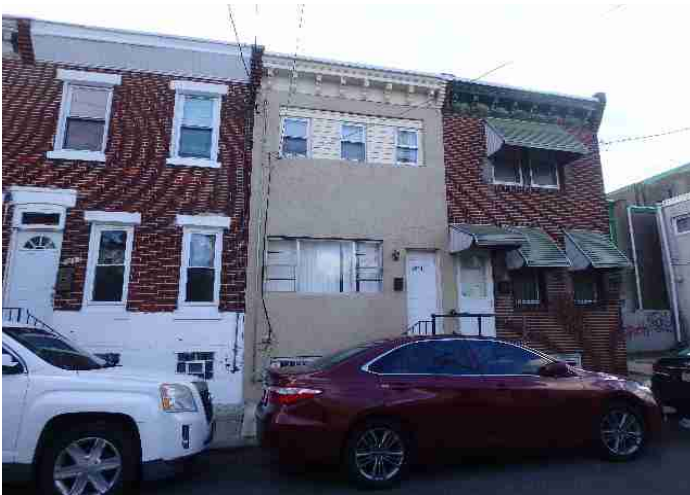
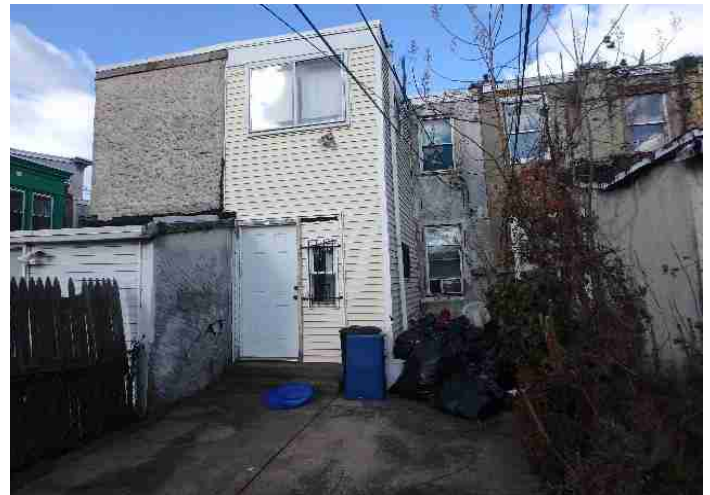
13.1 - This building is covered with more than one type of siding material which are listed here: Stucco and vinyl siding.

The various intersections where the different siding materials meet should be monitored for cracks and separations.
